# KAWERAU DISTRICT COUNCIL Asset Management Plan 2020

Stormwater

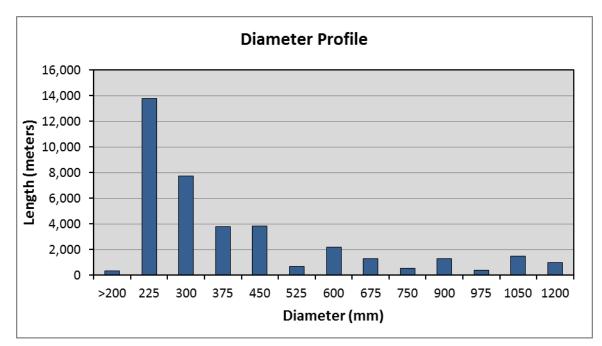
The size and age distribution of the network is illustrated below.

Figure 1: Diameter Profile of Stormwater Pipes

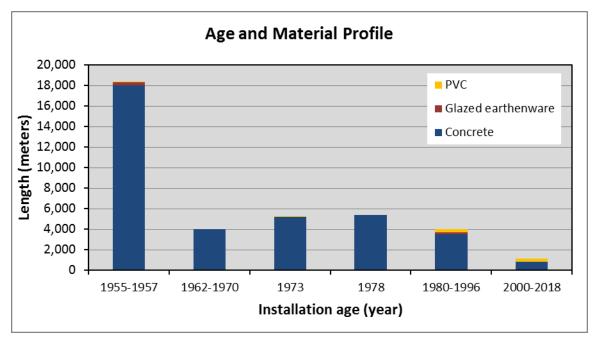
Figure 2: Age/Material Profile of Stormwater Pipes
